P.I.N. X051.59  
BRIDGE DECK EVALUATION REPORT

<u>Description:</u>	Grand Central Parkway over Winchester Blvd and Cross Island Parkway and Ramp "H" over Cross Island Parkway
<u>BIN:</u>	1065149 and 106514A
<u>GCP Reference Marker:</u>	1120 to 1124
<u>County:</u>	Queens
<u>City of:</u>	New York
<u>Region:</u>	11
<u>Feature Carried:</u>	Grand Central Parkway and GCP Ramp "H"
<u>Feature Crossed:</u>	Cross Island Parkway Winchester Blvd

# IN-DEPTH INSPECTION REPORT

**B.I.N. 1-06514-9 & 1-06514-A**

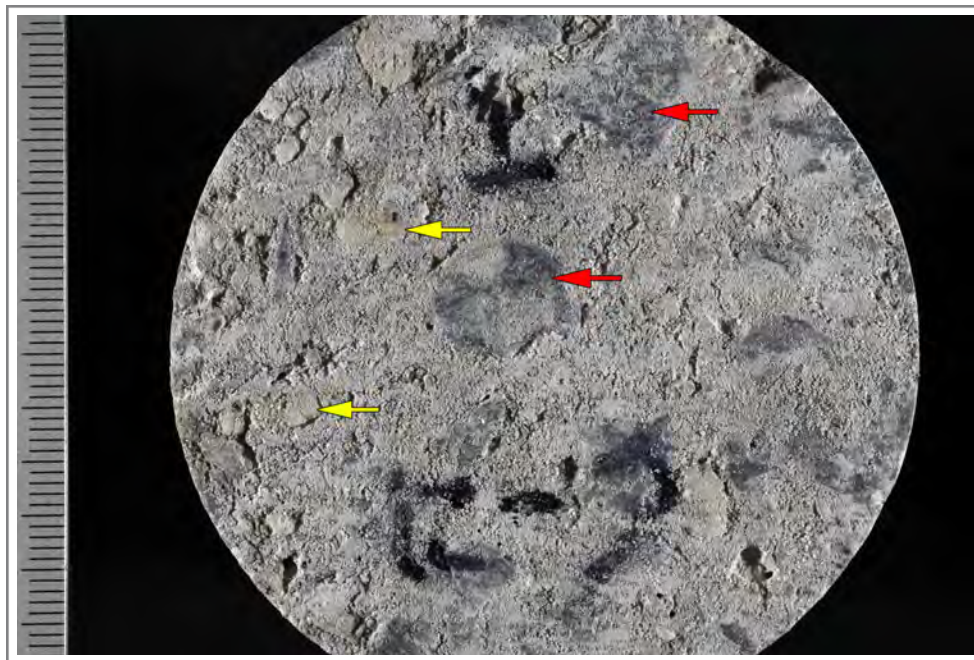
Figure E2. Photograph of the as-received condition of the top surface of the core. Red and yellow arrows indicate exposed coarse and fine aggregate particles, respectively. Scale shows millimeter increments.

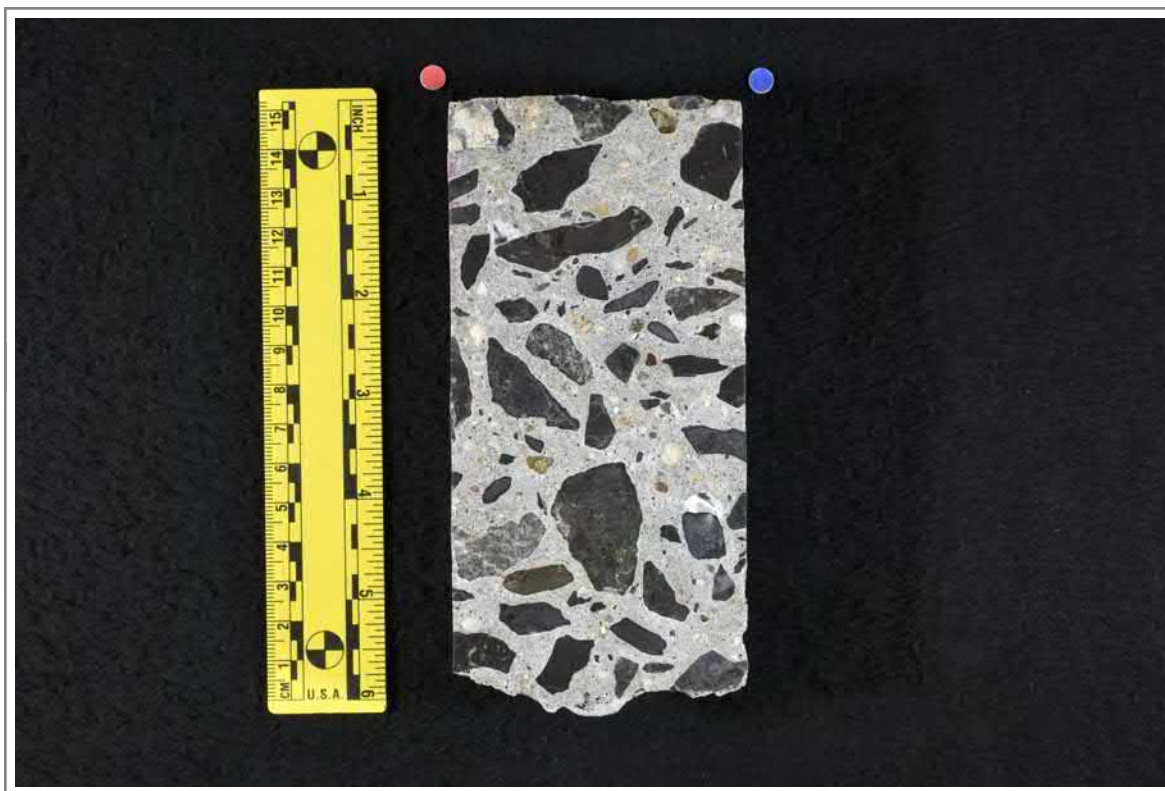
Figure E3. Photograph showing the polished surface of the slab prepared from the core. The red and blue dots show the orientation of the saw cuts used to prepare the core. The yellow scale is ~150 mm (6 in.) long; the small and large divisions are in centimeters and inches, respectively.

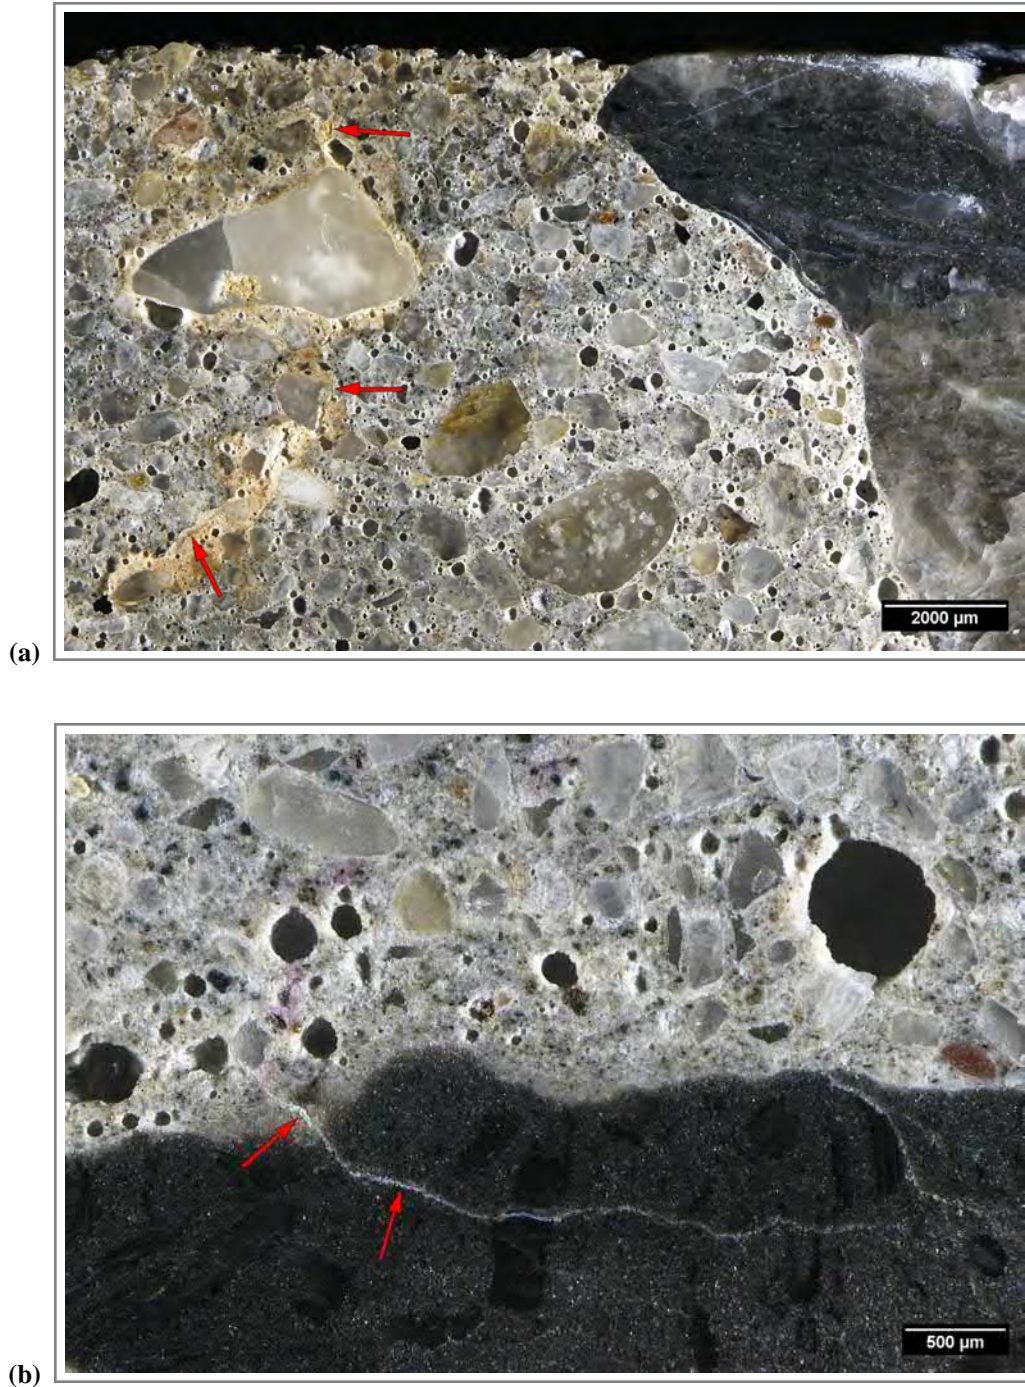
**Figure E4. Reflected light photomicrographs showing detail of (a) sub-vertical microcracks (red arrows) in the near-surface region of the paste and (b) randomly-oriented and ASR gel-filled microcracks (red arrows) extending outwardly from a reactive coarse aggregate particles.**

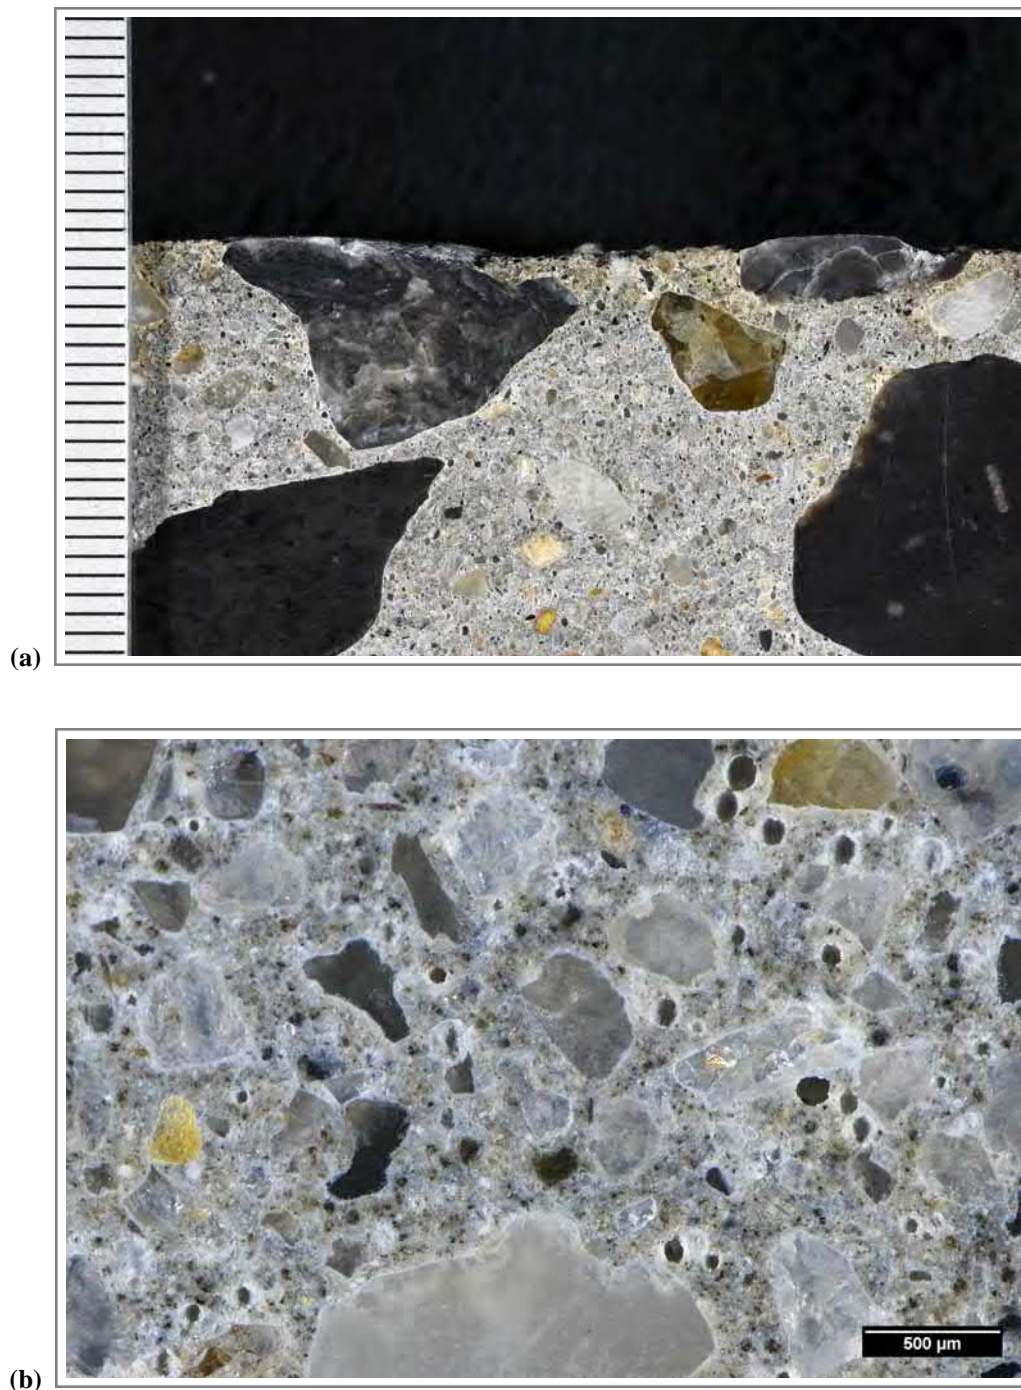
POLISHED SURFACE	Paste in the top 5 mm (¼ in.) is locally light beige; remainder of paste is light gray (Munsell Soil Color GLEY 1 7/N) ( <b>Figure E5</b> ). Paste throughout the core is hard (Mohs 3.5-4). The paste has a smooth texture and sub-vitreous luster.
FRESH FRACTURE	Freshly fractured surfaces show same coloration and luster, and exhibit a moderately weak paste-aggregate bond such that the concrete fractures around ~75% of coarse aggregate particles when struck with a geology hammer in the petrographic laboratory ( <b>Figure E6</b> ).
THIN SECTION	Thin section evaluation was not performed.
ESTIMATED W/C	Thin section evaluation was not performed; w/c was not estimated.

**Figure E5. Images showing detail of the paste. (a) Photograph showing paste in the near-surface region of the core. Scale shows millimeter increments. (b) Reflected light photomicrograph showing paste detail in the body of the core.**

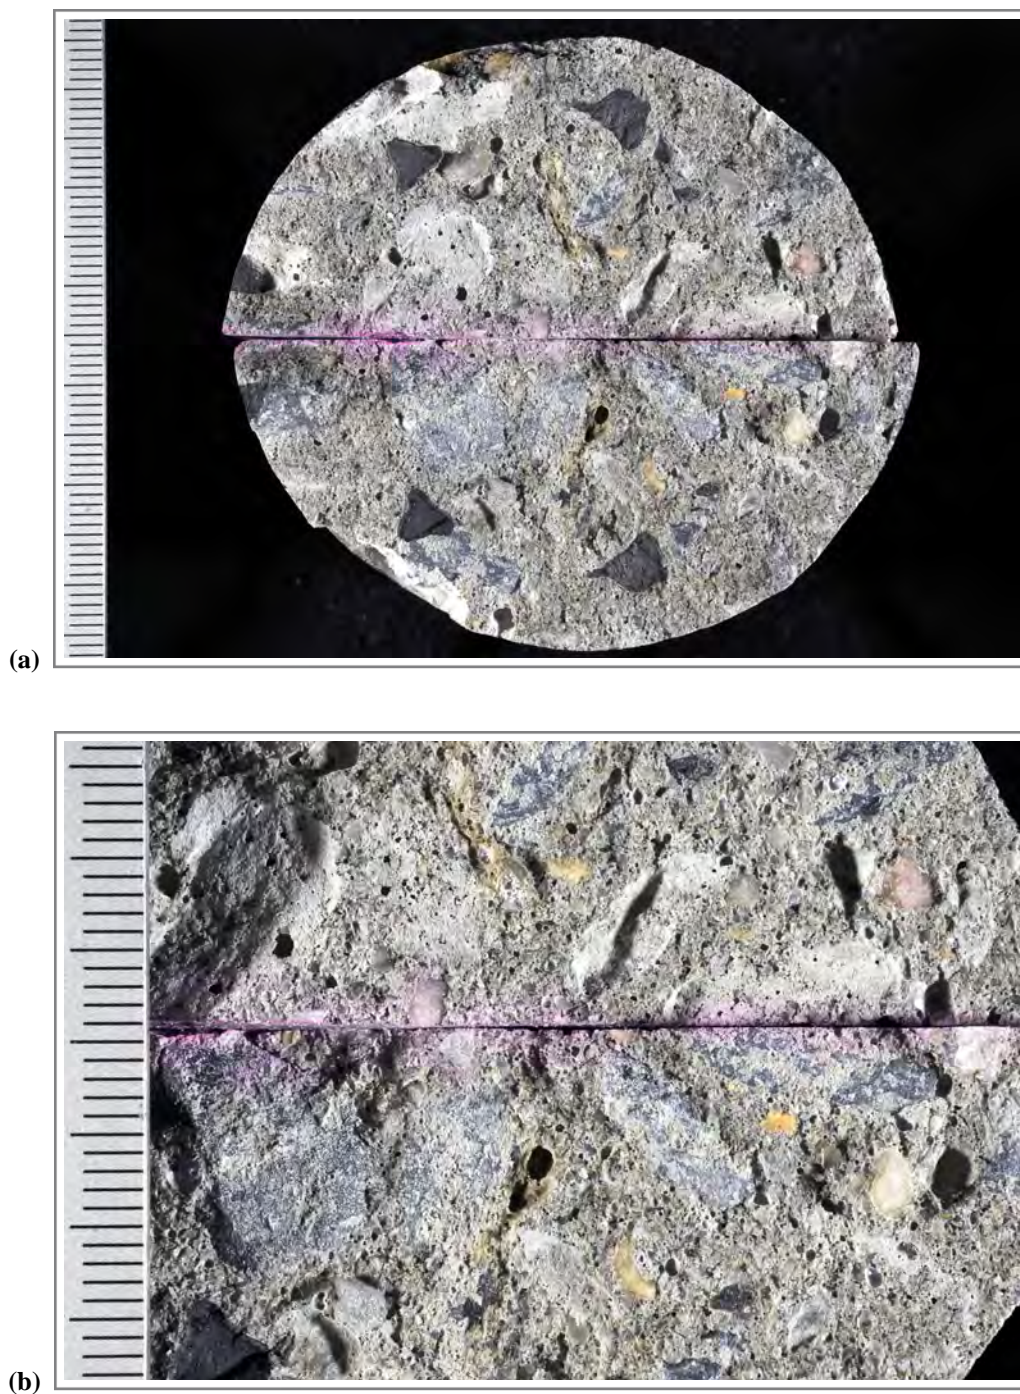
**Figure E6. Photographs showing (a) overview and (b) detail of freshly fractured concrete surfaces. Scale in both images shows millimeter increments.**

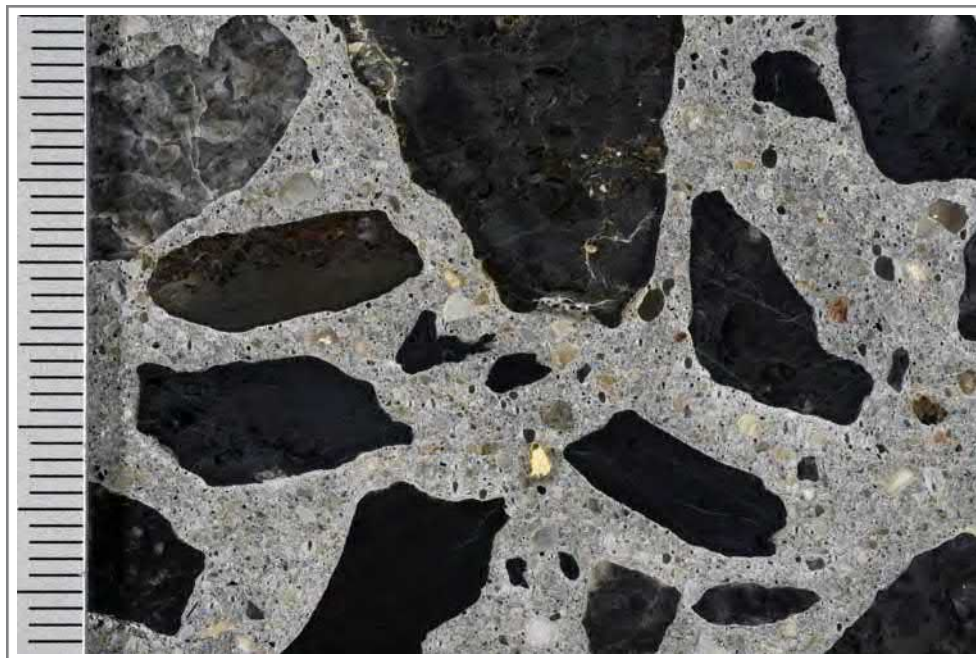
PHYSICAL PROPERTIES	The coarse aggregate is a crushed carbonate rock with a 19 mm (¾ in.) nominal top size ( <b>Figure E7</b> ). The rocks are hard and competent. The particles are equant to elongated in shape with angular to sub-angular edges and rough surfaces. Aggregate distribution is somewhat non-uniform and gradation is fairly uneven with a low volume of intermediate sized particles. No aggregate segregation is observed.
ROCK TYPES	The coarse aggregate is carbonate in composition and consists of limestone. Some particles exhibit minor to trace amounts of quartz, chert, and/or pyrite. Particles containing siliceous material (quartz, chert) are potentially susceptible to alkali-silica reaction (ASR). No particles are potentially susceptible to alkali-carbonate reaction (ACR); carbonate particles do not contain dolomite or textural characteristics typical of potentially reactive aggregate.

**Figure E7.** Photograph of the polished surface showing detail of the coarse aggregate. Scale shows millimeter increments.

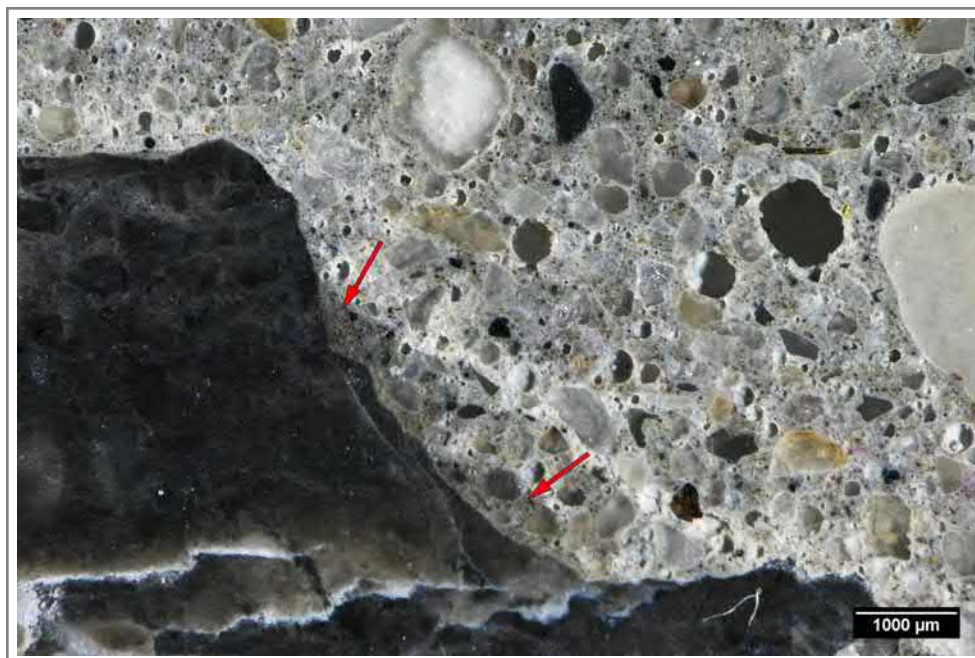
OTHER FEATURES	Evidence of ASR is present in the form of trace ASR gel in rare microcracks extending outwardly from reactive coarse aggregate particles and ASR gel lining to filling rare voids adjacent to reactive coarse aggregate particles. No evidence of ACR is observed. No deleterious coatings or encrustation are observed. Rare low w/c coatings are observed ( <b>Figure E8</b> ).

**Figure E8.** Reflected light photomicrograph of the polished surface showing low w/cm mortar coatings (red arrows) along a coarse aggregate particle.

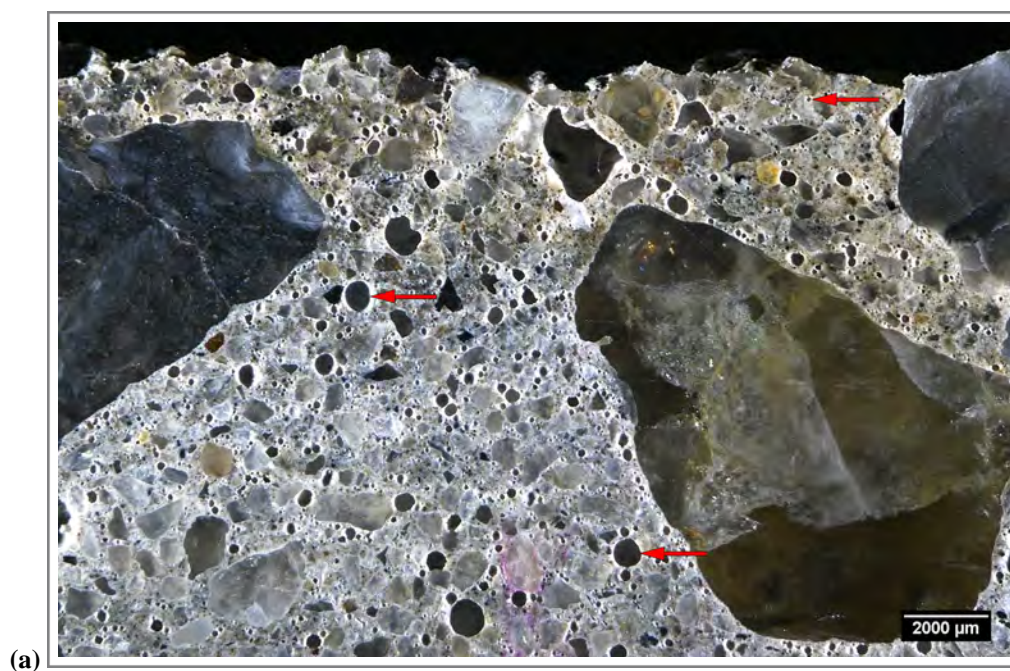
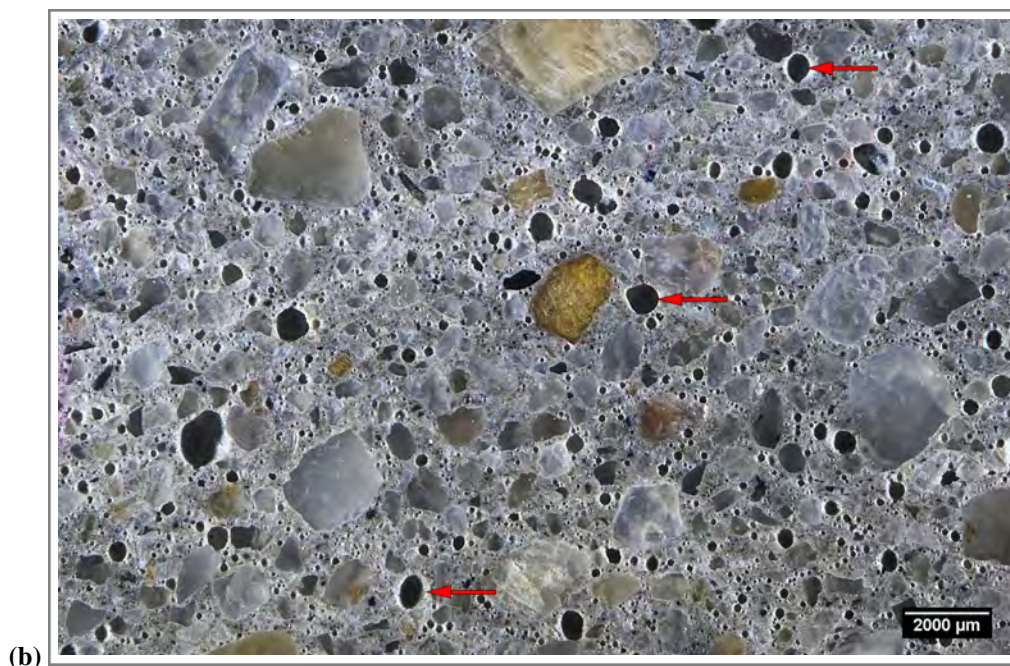
VOID SYSTEM	The concrete is air-entrained and has an estimated 6-7% total air content. Several spherical voids are observed throughout the depth of the core ( <b>Figure E10</b> ). Few entrapped voids are occasionally present throughout the core. The concrete is well consolidated with no notably large entrapped voids.
VOID FILLINGS	Ettringite occasionally lines voids throughout the core. ASR gel rarely lines to fill voids adjacent to reactive coarse aggregate particles throughout the core. See <b>Figure E11</b> .

Figure E10. Images showing detail of voids within the core. (a) Reflected light photomicrograph showing detail of voids (red arrows) in the top portion of the core.

**Figure E10 (cont'd). Images showing detail of voids within the core. (b) Reflected light photomicrograph showing detail of voids (red arrows) in the middle of the core.**

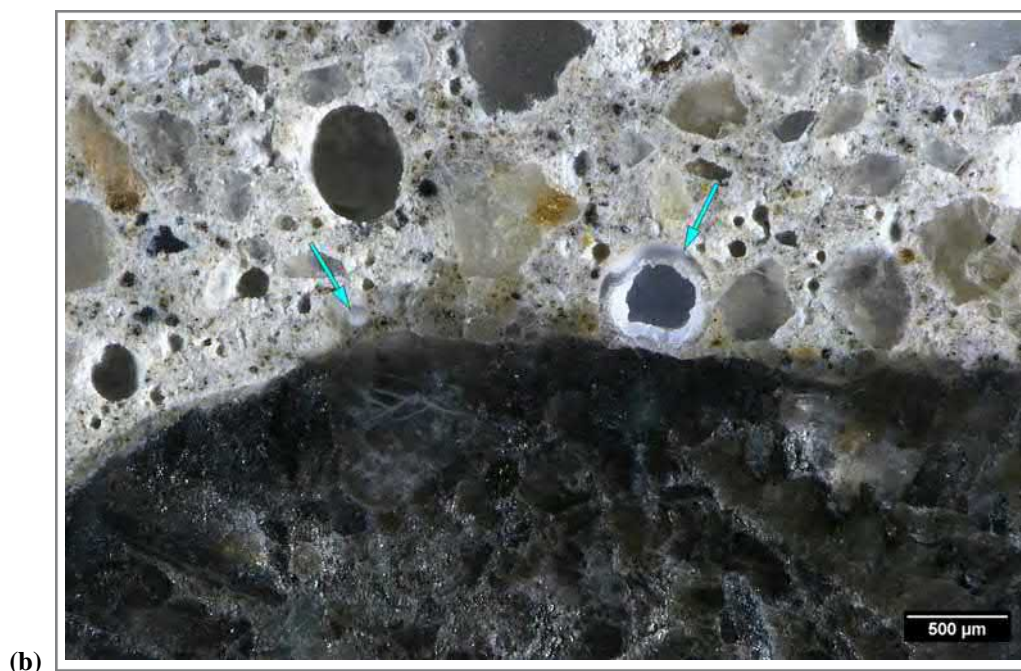
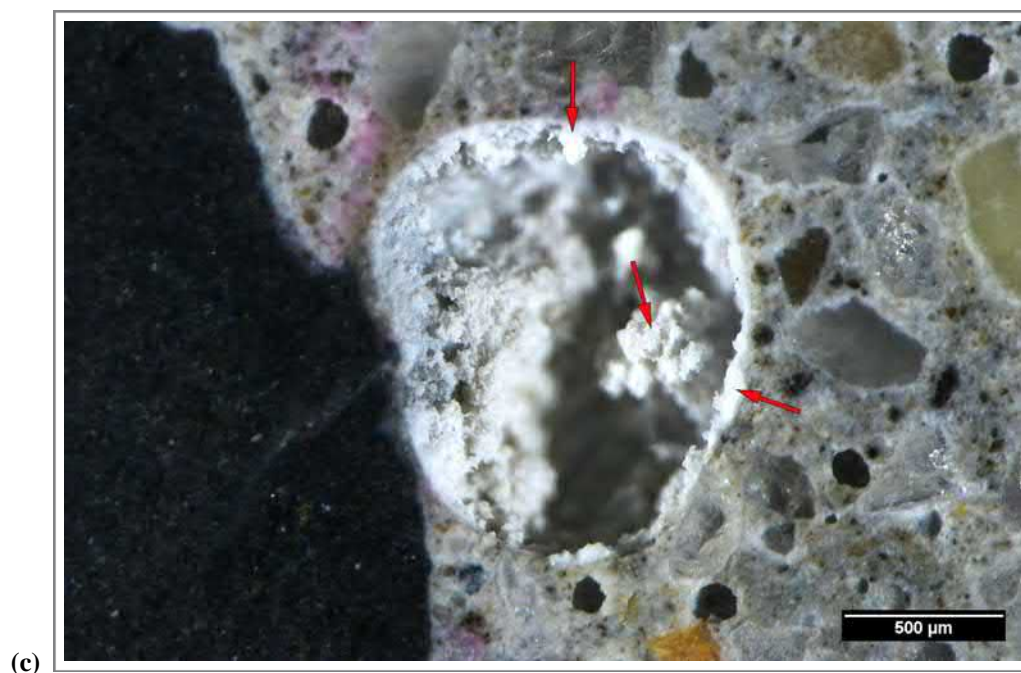
**Figure E11. Images showing detail of secondary deposits in voids. (a) Reflected light photomicrograph of the polished surface showing ASR gel (blue arrows) lining a void. Red arrow indicates ASR gel-filled microcrack in adjacent reactive coarse aggregate particle.**

**Figure E11 (cont'd).** Images showing detail of secondary deposits in voids. (b) Reflected light photomicrograph of the polished surface showing ASR gel (blue arrows) lining to filling a couple voids. (c) Reflected light photomicrograph of the polished surface showing ettringite (red arrows) within a void.

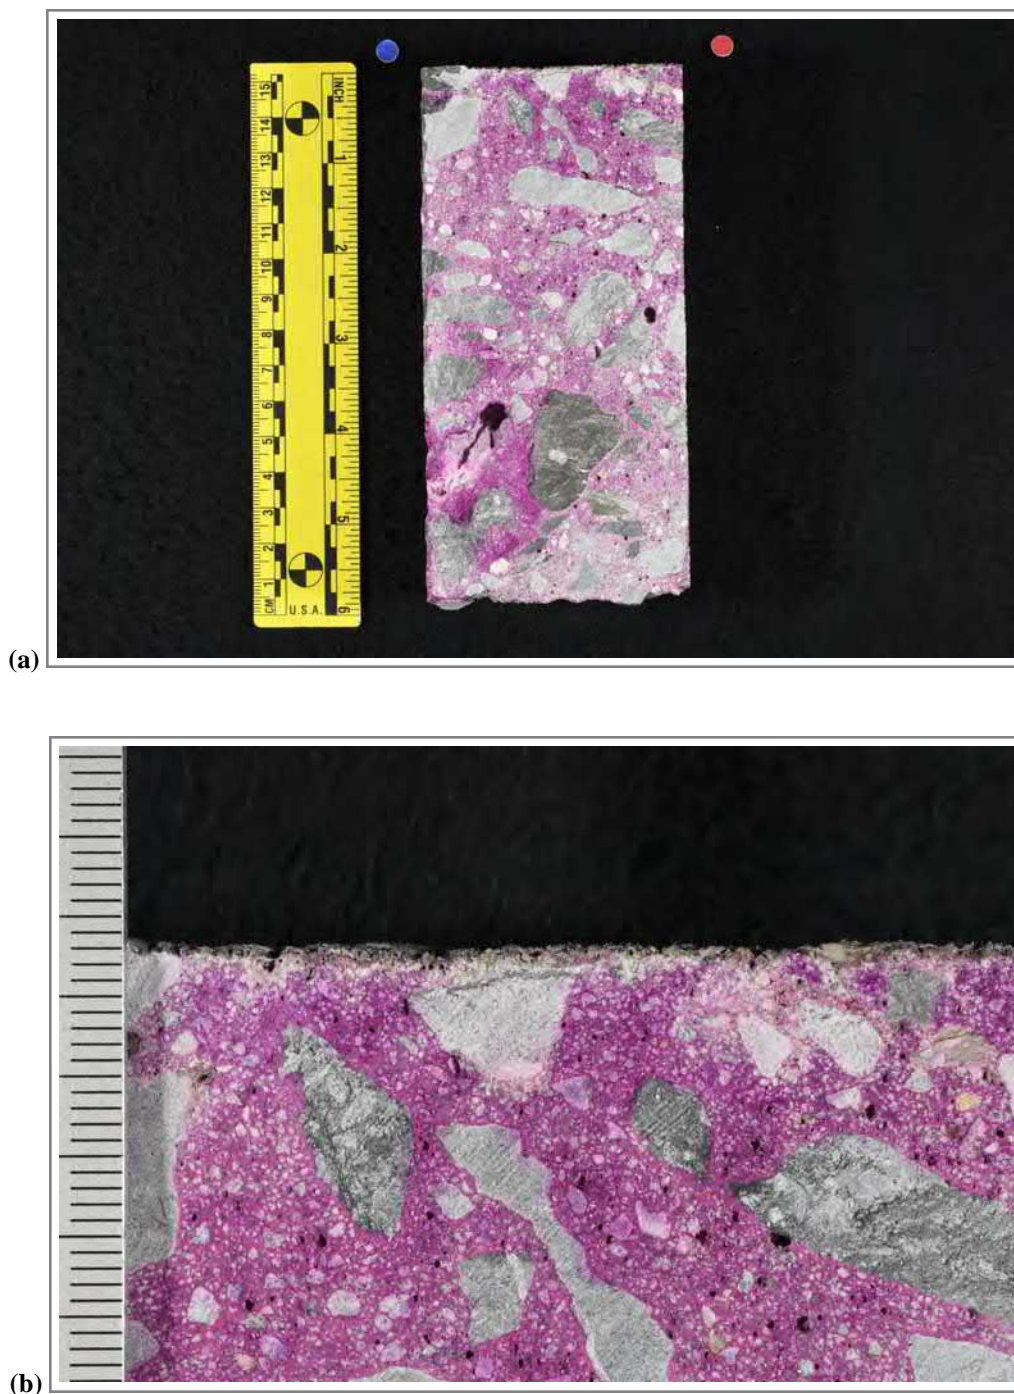
PHENOLPHTHALEIN	The paste is carbonated in the top 1 mm (40 mil) with locally deeper carbonation along sub-vertical microcracks ( <b>Figure E12</b> ). Phenolphthalein staining was applied to a freshly saw-cut cross-sectional surface of the core to determine general depth of paste carbonation.
SECONDARY DEPOSITS	Other than ettringite in voids and ASR gel in microcracks and voids, no additional secondary deposits are observed.

**Figure E12. Photographs showing (a) overview of phenolphthalein-stained cross-sectional surface of the core, and (b) detail of stained surface at the top of the core. The yellow scale in (a) is ~150 mm (6 in.) long; the small and large divisions are in centimeters and inches, respectively. The scale in (b) shows millimeter increments.**
